EXECUTIVE SUMMARY

NASA and the Russian Space Agency (RSA) are involved in a cooperative venture in which the Shuttle will rendezvous and dock with the Mir Space Station during several missions from 1995 to 1998. This sequence of nine missions will serve as a precursor to the two nations' involvement in the International Space Station. These joint missions provide NASA scientists and engineers an opportunity to study the orbital, dynamic, and environmental conditions of long duration spacecraft, as well as develop evaluation and risk mitigation techniques which have direct application to the International Space Station.

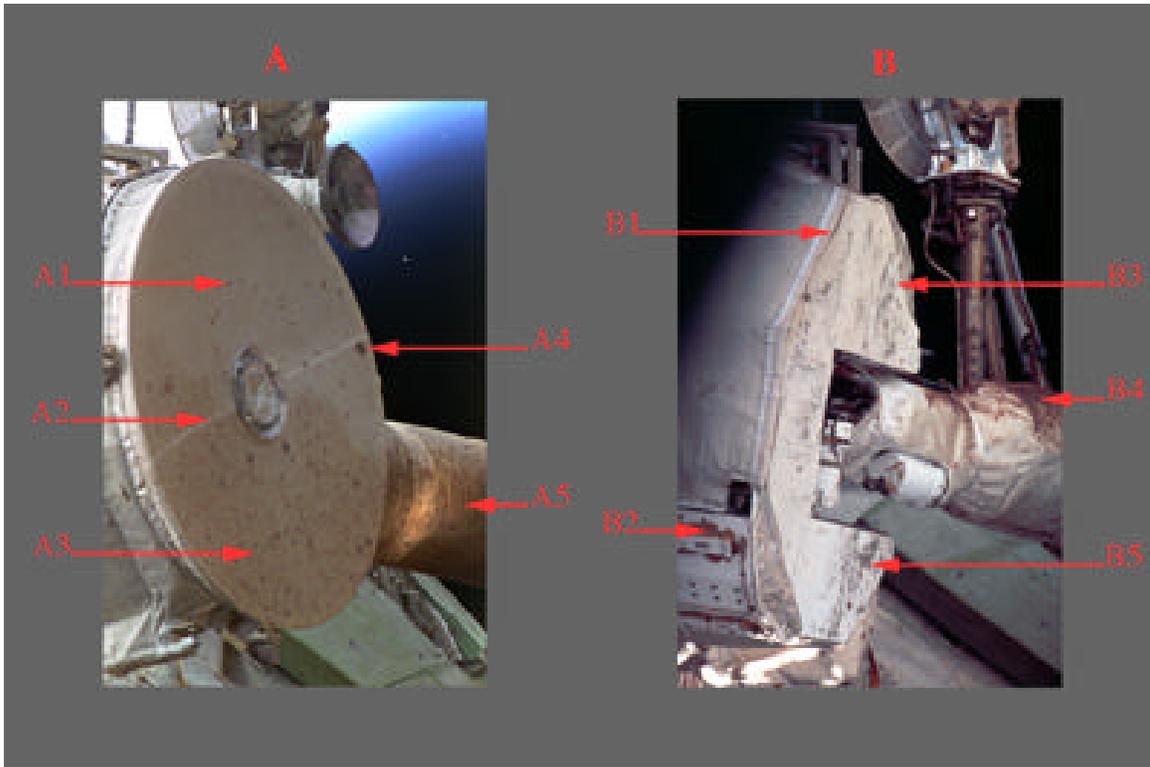
Figure 3.1a Mir Base Block - Luch antenna

The face side of the Luch antenna is shown in the A diagram. The back side of the Luch antenna is shown on the B diagram. The two sides have markedly different patterns of discoloration. The face side has a spotted pattern of discoloration [A3, A4, A5] with one preferential, circular pattern of dark spots [A1]. The back side has irregular discolorations [B2, B3, B4, B5]. A thermal blanket also has a detached edge [B1].

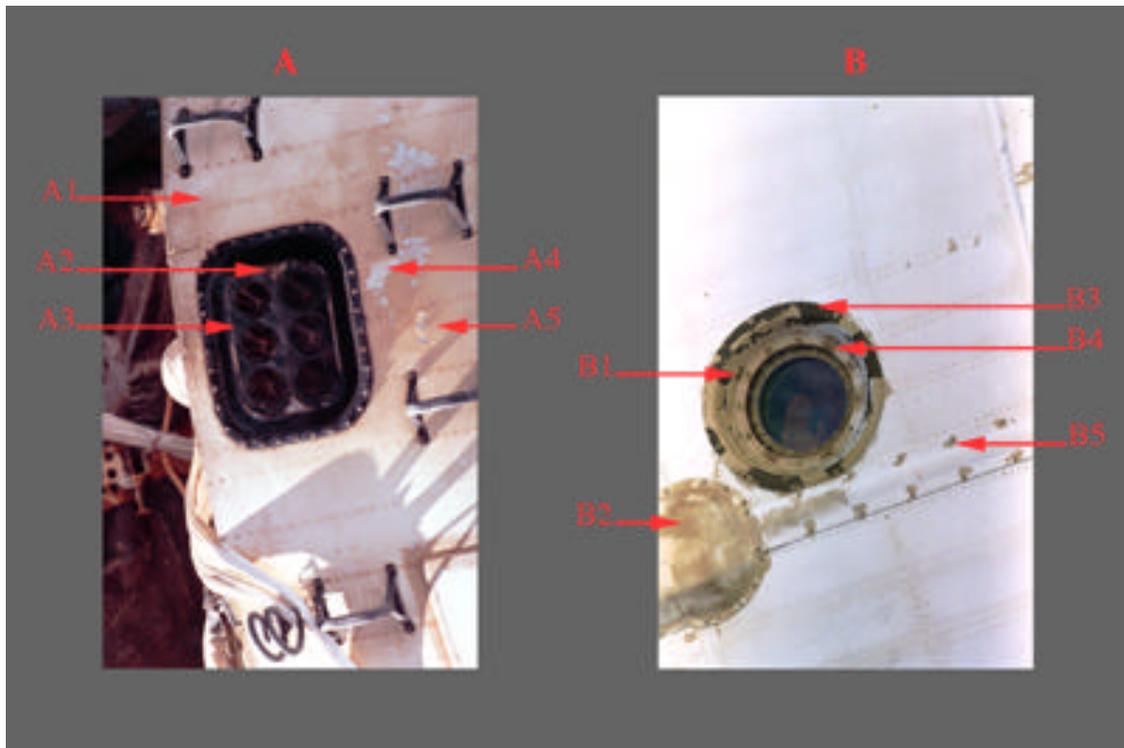
Figure 3.1b Mir Base Block - Thruster Engines and Optical Window

The thruster engines and surrounding area are characterized by light orange discoloration [A1], discoloration on the metallic structure of the thruster engines [A2], blistering of the paint on the thruster engine structure [A3], and blistering and peeling of paint on the propulsion section [A4, A5]. The optical window and surrounding area are characterized by areas of peeling paint on the inner and outer metallic ring of the optical window [B1, B3], brown discoloration patches on the raised sections [B2] and around the support bolts of the window and module [B4, B5].

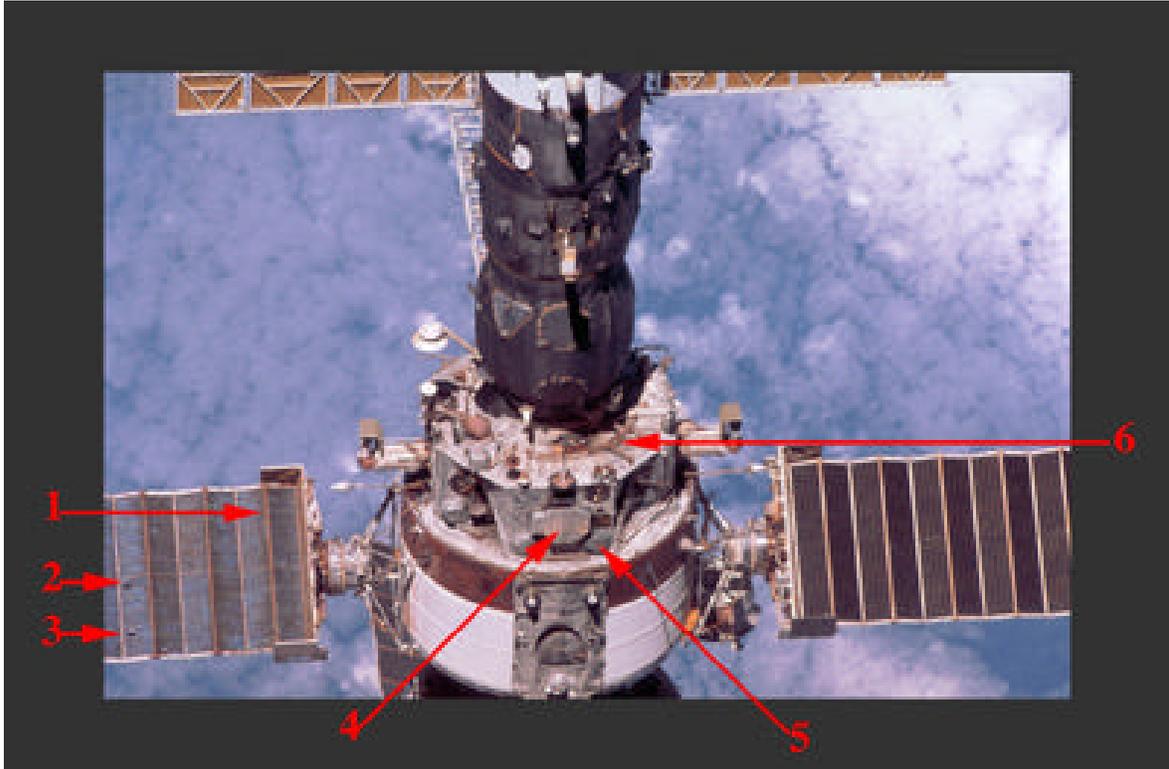
Figure 3.2a Kvant - Aft Facing Section of the Module in the $-Y_B$ Direction

- Dark brown discoloration around the support structure of the solar array. [1]
- Detachment of S/A cells. [2, 3]
- Discoloration and blistering on the thermal blanket. [4, 5, 6]

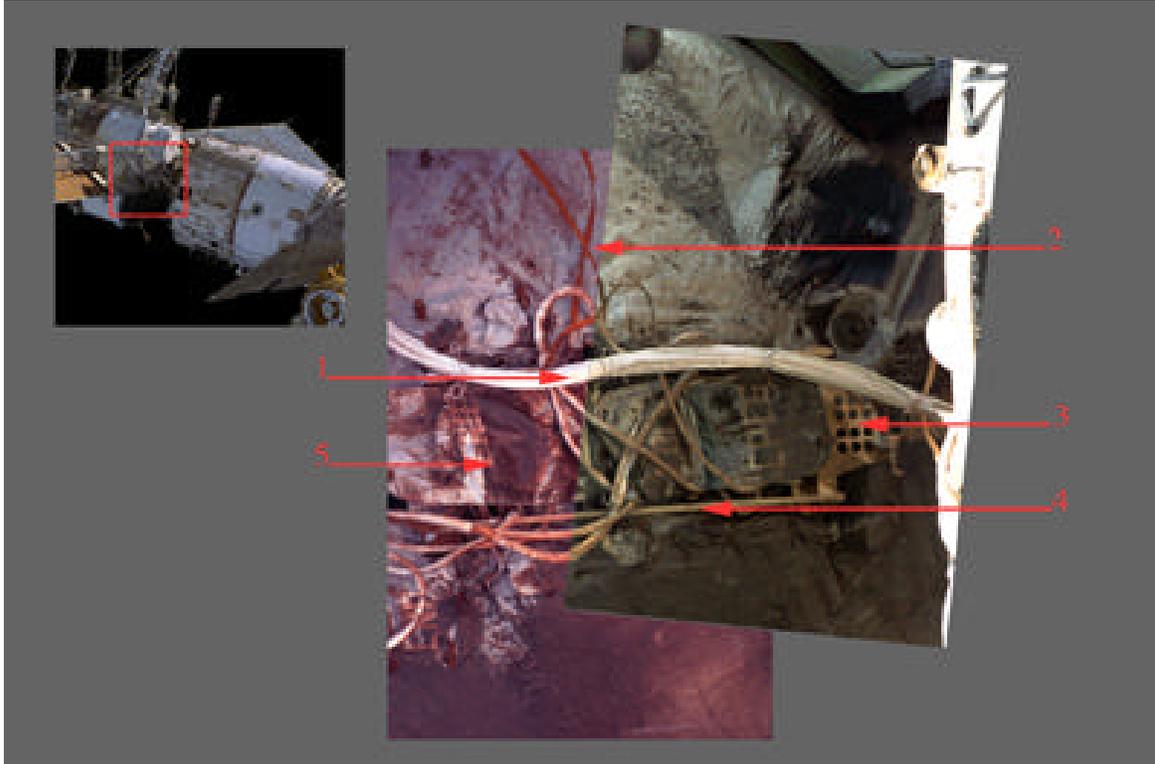
**Figure 3.2b Kvant - Docked Section Aft of the Base Block in the
-Z_B Direction**

The conical-shaped section of the Kvant module is shown as a mosaic of two 35 mm images. Various cables that connect the Kvant and Base Block modules are seen in this image. Discolorations observed in the image are a dark spot on the cable connecting the CSA and the Base Block [1], and dark color discoloration on the metallic structure [3], support structure [4] and the thermal blanket [5].

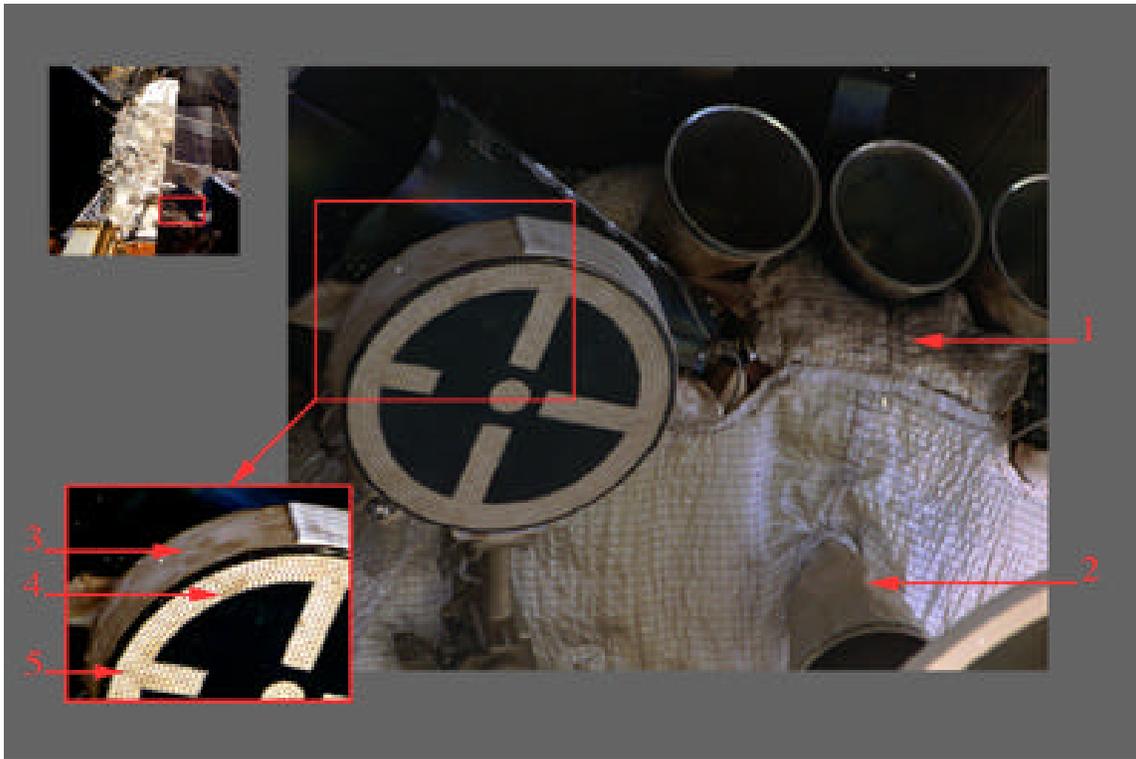
**Figure 3.3a Kristall - Buran TV Target and Thruster Engines in the
-X_B Direction**

- Discoloration and charring of the thermal blanket around the thruster engines. [1]
- Patches of discoloration and possible deposition on the edge and face sides of the target. [3, 4, 5]

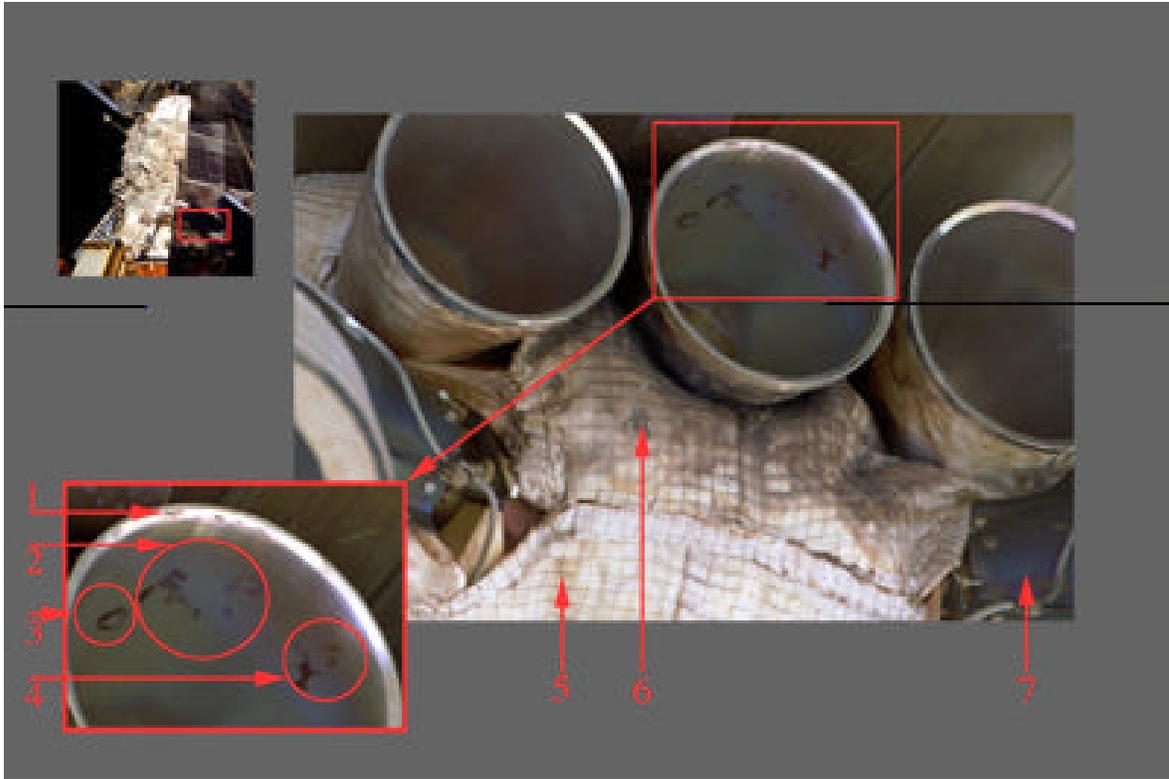
**Figure 3.3b Kristall - Mooring and Stabilization Engines in the
-XB Direction**

- Discoloration or scratch marks on the outer edge of the thruster engine nozzles. [1]
- Discoloration or deposition on the interior wall of the thruster engine nozzles. [2, 3, 4]
- Faint and dark color patches and blistering of the thermal blanket. [5, 6]
- Peculiar color patterns on metallic surfaces. [7]

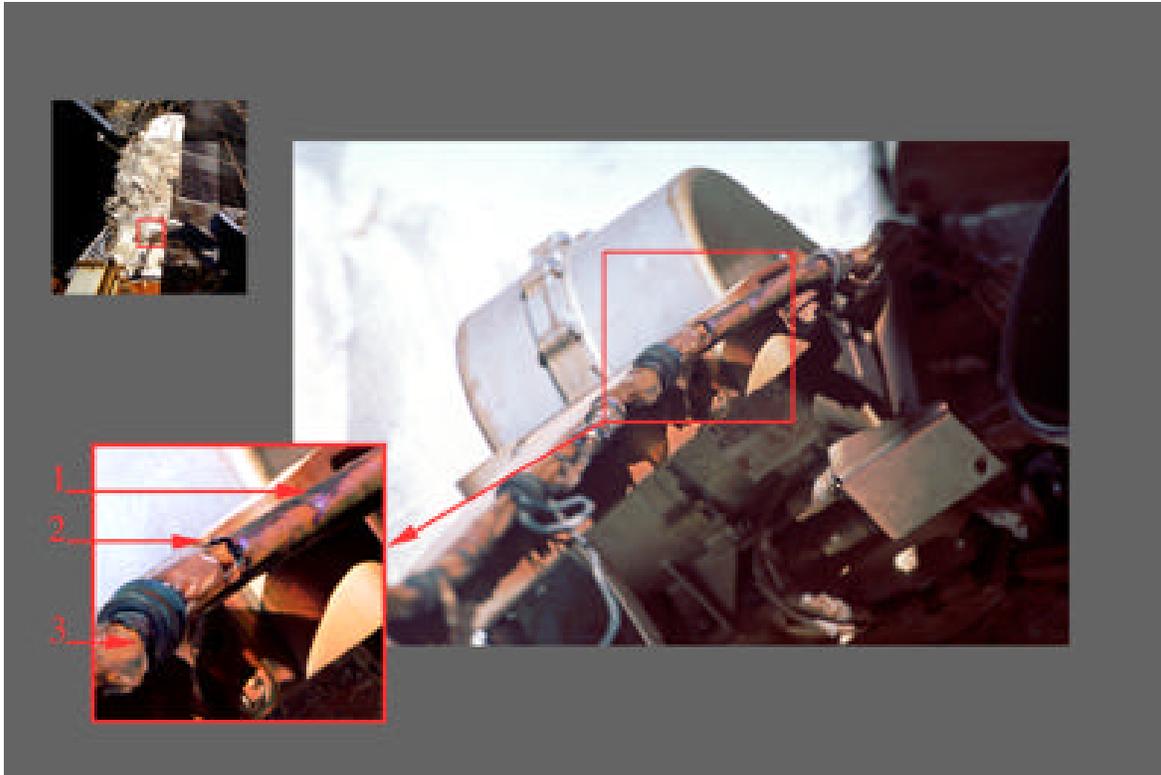
Figure 3.3c Kristall - Igla Antenna Cable Mechanism in the -XB Direction

- Charring and probable burn-throughs were found in the protective casing of the Iгла antenna cable attached to Kristall. See Section 3.
- Additional paint was missing on the Spektr radiator as compared to that identified in the STS-79 mission report. See Section 3.

This is a detailed view of an Igla antenna's cable mechanism on the Kristall module. In this view, the outer jacket of the cable shows a possible burn-through. The inset image is an enhanced illustration of this damage. The following surface effects are identified:

- Dark color discoloration or charred area on the cable. [1]
- A possible burn-through section of the cable. [2]
- A possible break in the cable harness. [3]

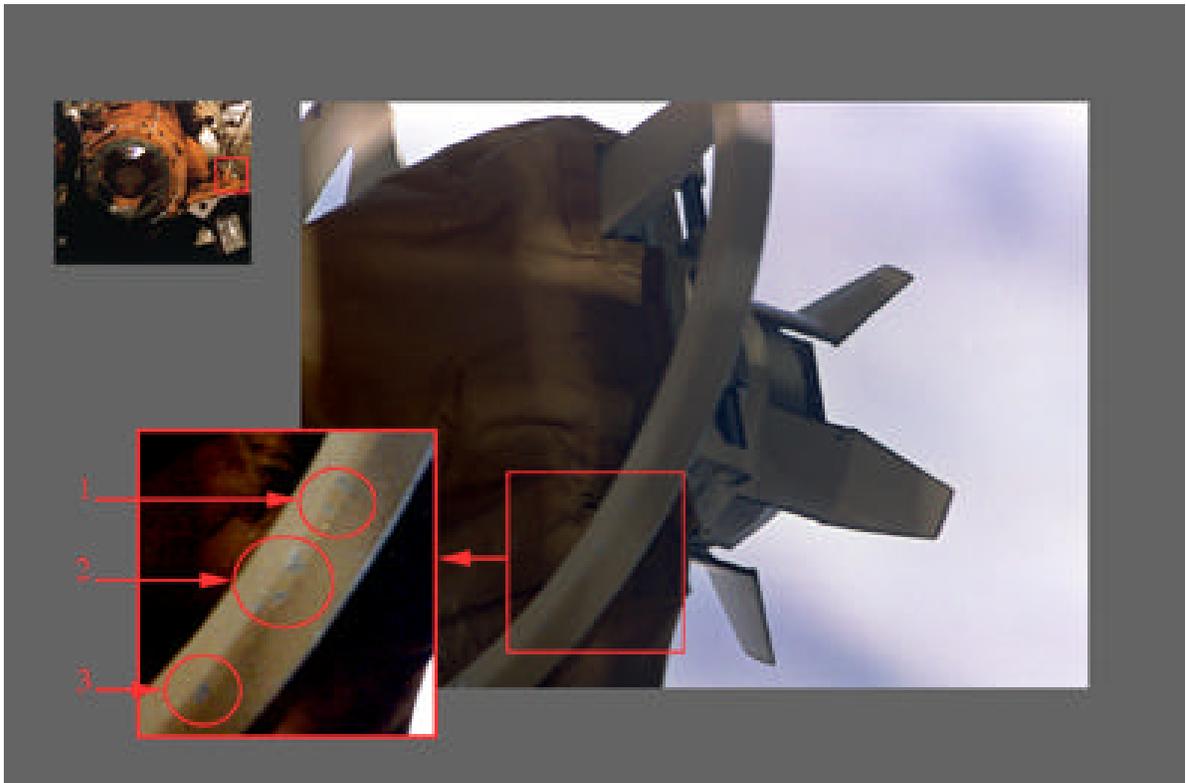
Figure 3.4a Docking Module - ROEU-PDA

This is a detailed view of the Remotely Operated Electrical Umbilical (ROEU) Payload Disconnect Assembly (PDA) located on the Docking Module. In this view, the handrail on the ROEU-PDA shows prominent scratch marks or dents as shown in items 1, 2, and 3.

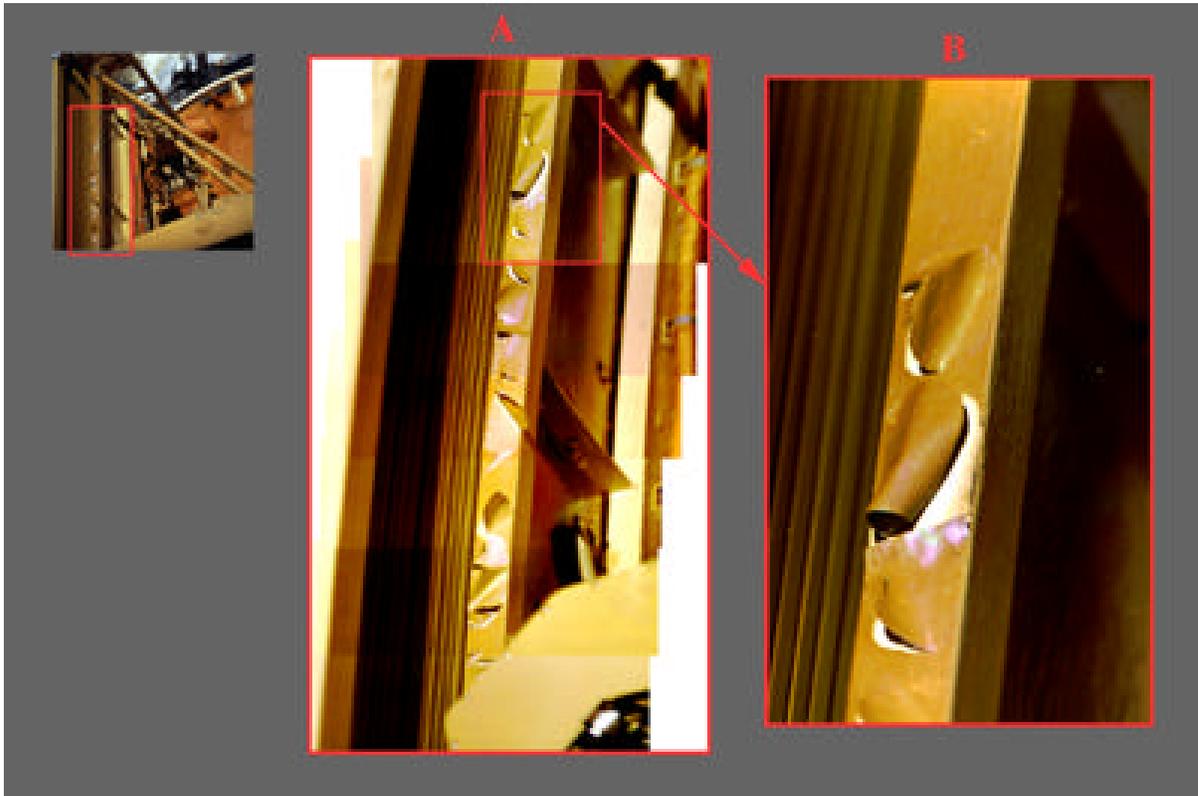
Figure 3.4c Docking Module - RSA

A comparison of the paint peeling on STS-76 versus STS-81 is shown in Figure 3.4d.

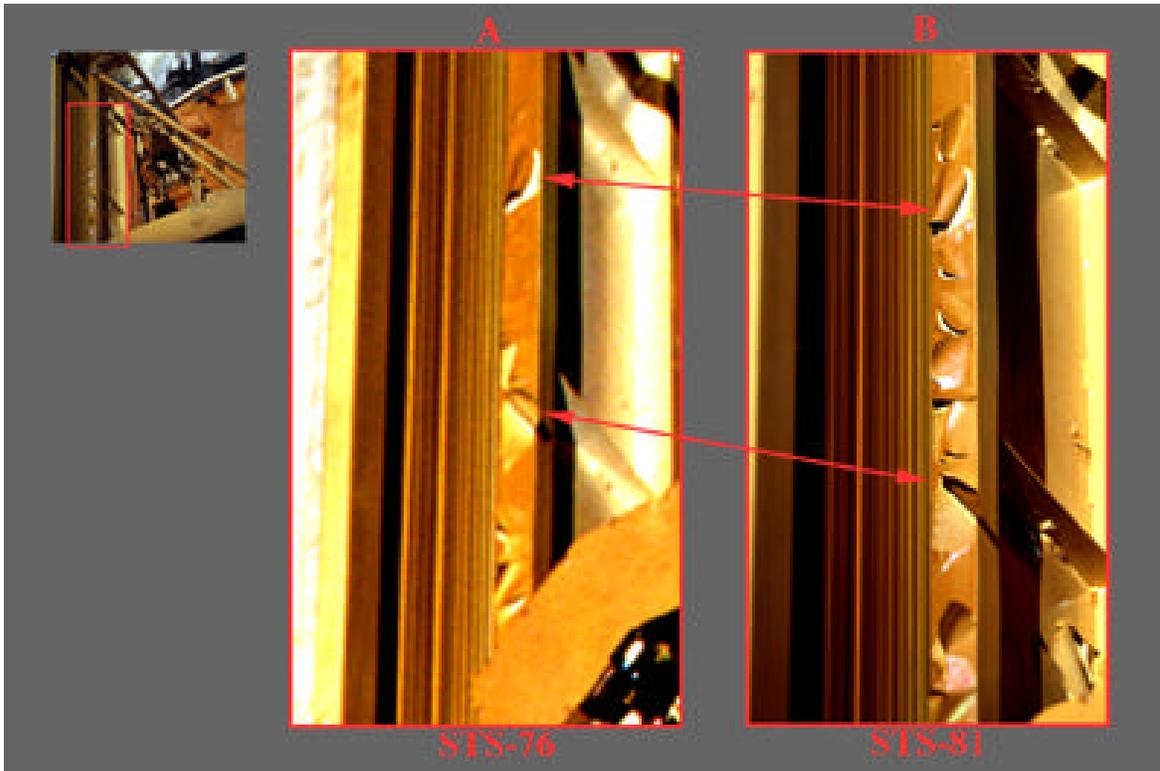
Figure 3.4d Docking Module - Comparison of RSA: STS-76 vs STS-81

- Additional areas of peeled paint were found on the upper side of the Reusable Solar Array (RSA) carrier. During STS-79, large areas of paint were identified as peeling on the lower side of the RSA. See Section 3.

Detailed views of the Reusable Solar Array (RSA) carrier from two different missions are shown in Figure 3.4d. The image obtained during the STS-76 mission is shown in the A diagram and the image obtained during the STS-81 mission is shown in the B diagram. It is apparent from these images that the amount of peeling paint on this upper part of the RSA carrier increased during the 10 months between these two missions. During STS-76 (image A), about 20% of the paint from the RSA carrier was found to be peeled. During STS-81 (image B), about 80% of the paint from the same RSA carrier edge appears to be peeled.

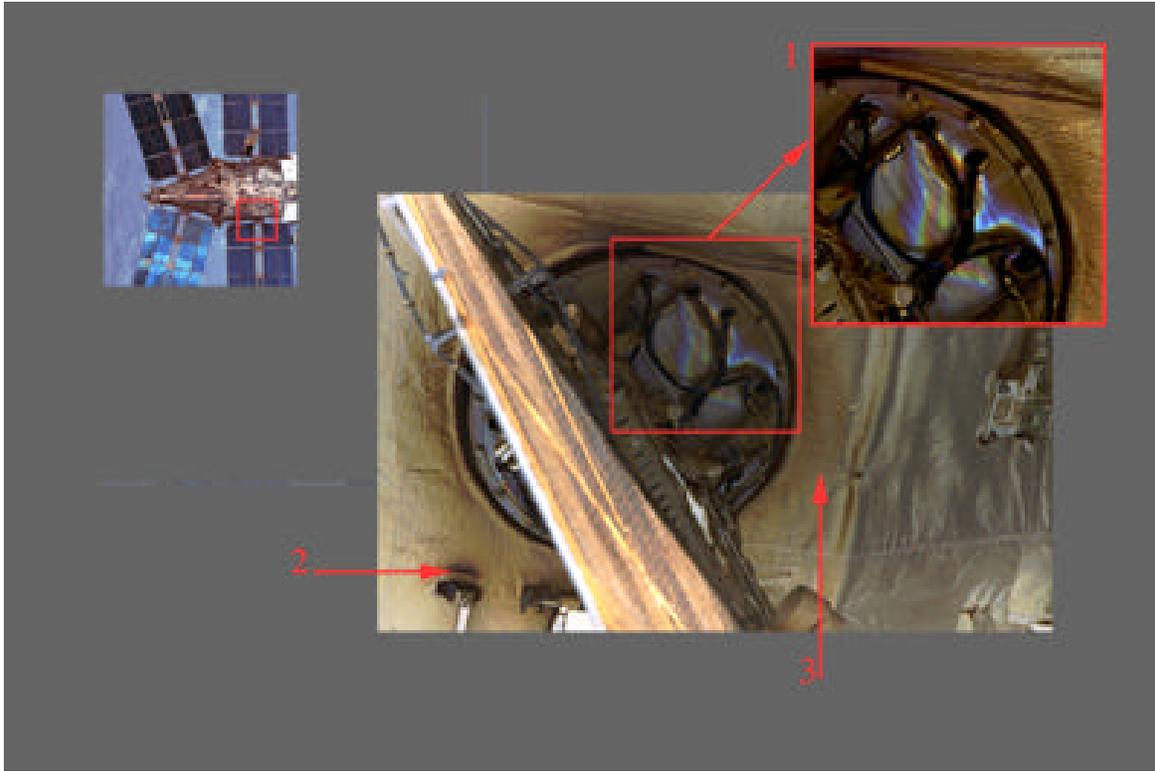
Figure 3.5a Spektr - Solar Array Attach Point: SP#2

This is detailed view of the solar array attach point on the Spektr module. In this view, the attach point of the SP#2 of the Spektr module is shown [1]. The attach area has a color pattern similar to interference of reflected light. A similar color pattern was also identified on a backplate located on the Docking Module (see Figure 3.4b). Discoloration of the thermal blanket are also shown [2, 3].

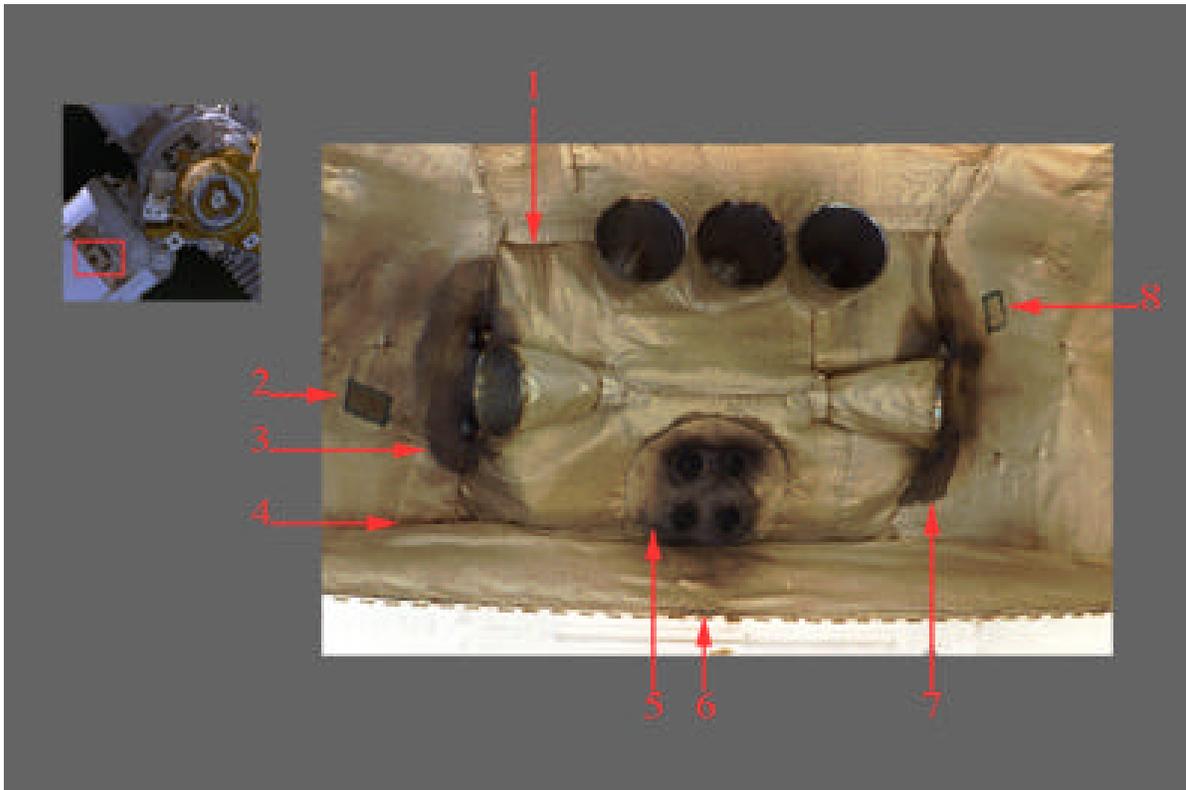
Figure 3.5b Spektr - Thruster Engines

- Dark discolorations of the thermal blanket and the areas beneath the engine cone. [1, 3, 4, 7]
- Attachments / patches on the thermal blanket. [2, 8]
- Charred areas of the thermal blanket in the vicinity of the engine exhaust. [5]
- The thermal blanket has small areas which appears to be detached from the surface. [6]

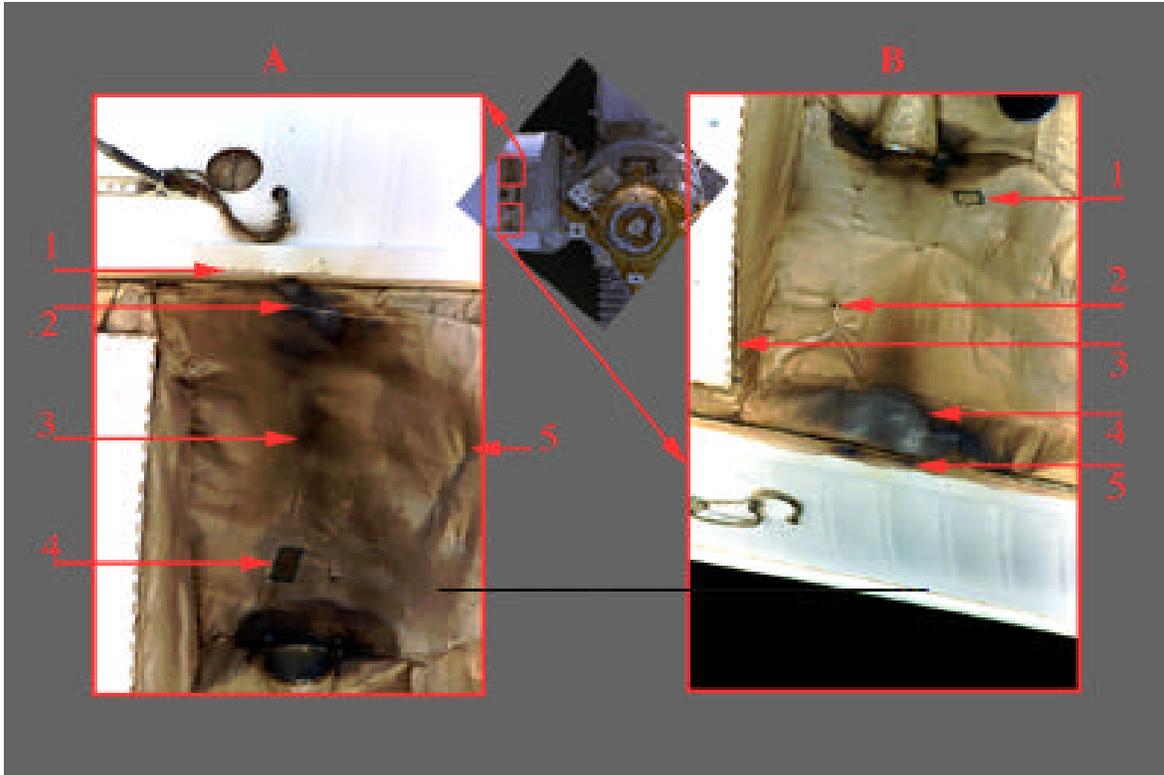
Figure 3.5c Spektr - Thruster Engines and Thermal Blankets

- Discoloration on the metallic surface in the plume line-of-sight. [A1]
- Dark discolorations / charred effects on the thermal blanket. [A2, A3, B4]
- Detailed views of attachments / patches. [A4, B1]
- Possible holes in the thermal blanket. [A5, B2]
- A radiator panel that appears to be detached at the edge. [B3]
- Charred effect on the metallic surface in the plume line-of-sight. [B5]

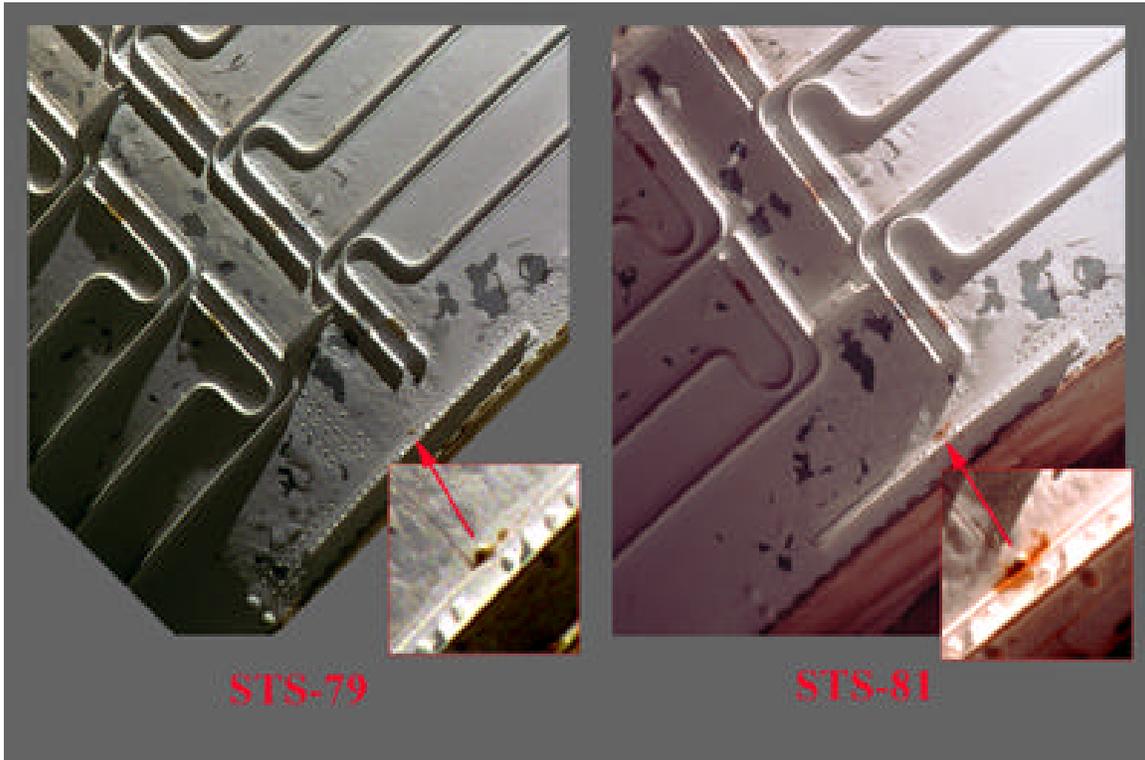
Figure 3.5d Spektr - Comparison of a Possible Radiator Leak: STS-79 vs STS-81

- A possible leak was discovered on the Spektr radiator. The leak existed on STS-76 and STS-79, but was small and went undetected. The area is still small (approximately 7 sq. cm.), but has significantly increased in size since STS-79. See Section 3.

In this figure, two different Spektr radiator images that were obtained four months apart on STS-79 (left) and STS-81 (right) are shown. The progression of the small leak in the radiator is shown in the enlarged inserts to the STS-79 and STS-81 imagery. The small leak in the Spektr radiator was first identified in the STS-81 high resolution imagery, obtained with the 35 mm camera and 400 mm lens while the Shuttle was docked to Mir. This leak shows as an orange-appearing color in the imagery. The leak appears to originate at a rivet which is in the corner of a radiator panel and adjacent to a structural reinforcement. A review of imagery showed the leak existed at the time of STS-76 and STS-79, but the affected area was very small at those times and went undetected in the imagery reviews. On STS-74, the imagery showed no apparent discoloration. By STS-76, the discolored area was isolated to the rivet only. On STS-79, the leak extended to include a small area along the edge of the structural reinforcement, and by STS-81 the affected area extended across the edge, and along the edge in both directions from the rivet. The size of the affected area was determined from the STS-81 imagery to be approximately 7 sq. cm.

Note also the regions of additional paint peeling on the radiator between STS-79 and STS-81. The STS-79 Mission Report identified both missing and blistered paint on the radiator.

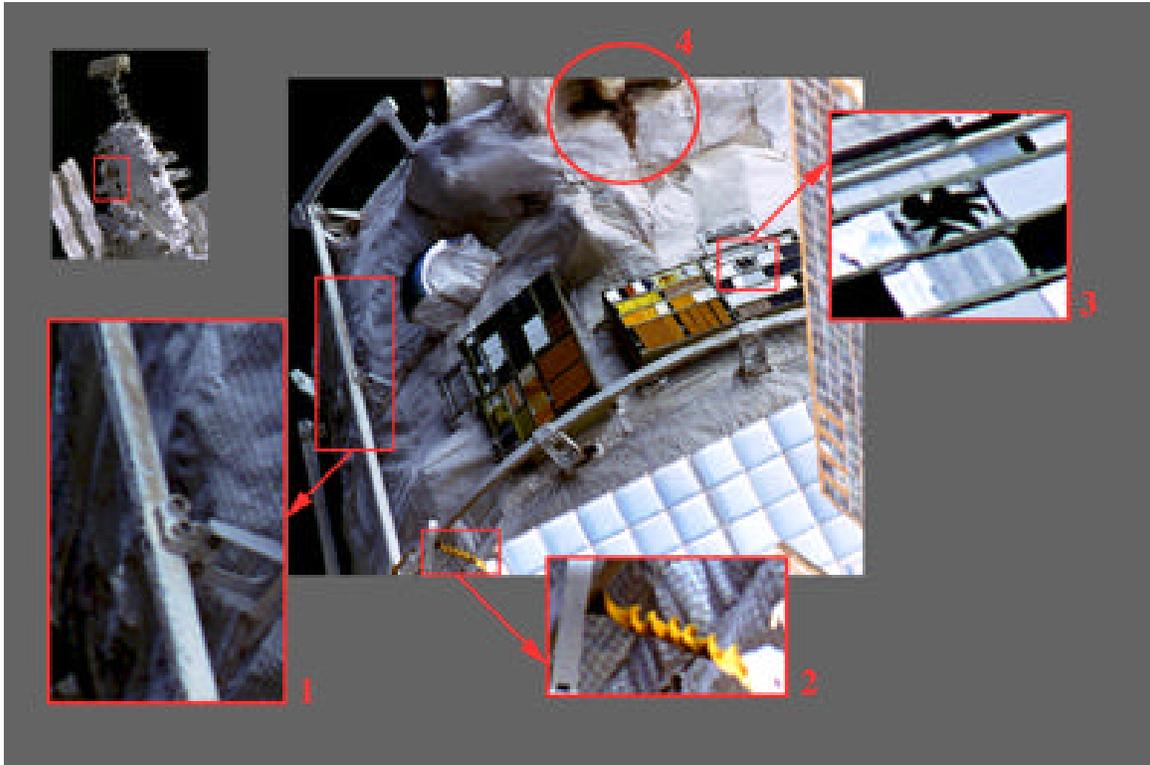
Figure 3.6 Kvant-2 - MSRE

- Dark discoloration on the EVA handrail. [1]
- A twisted cord that is attached to the MSRE, and a possible tear on MSRE. [2]
- One of the test blocks on the “Komplast” appears to be broken. [3]
- Dark discoloration on the seams / folds of the thermal blanket. [4]

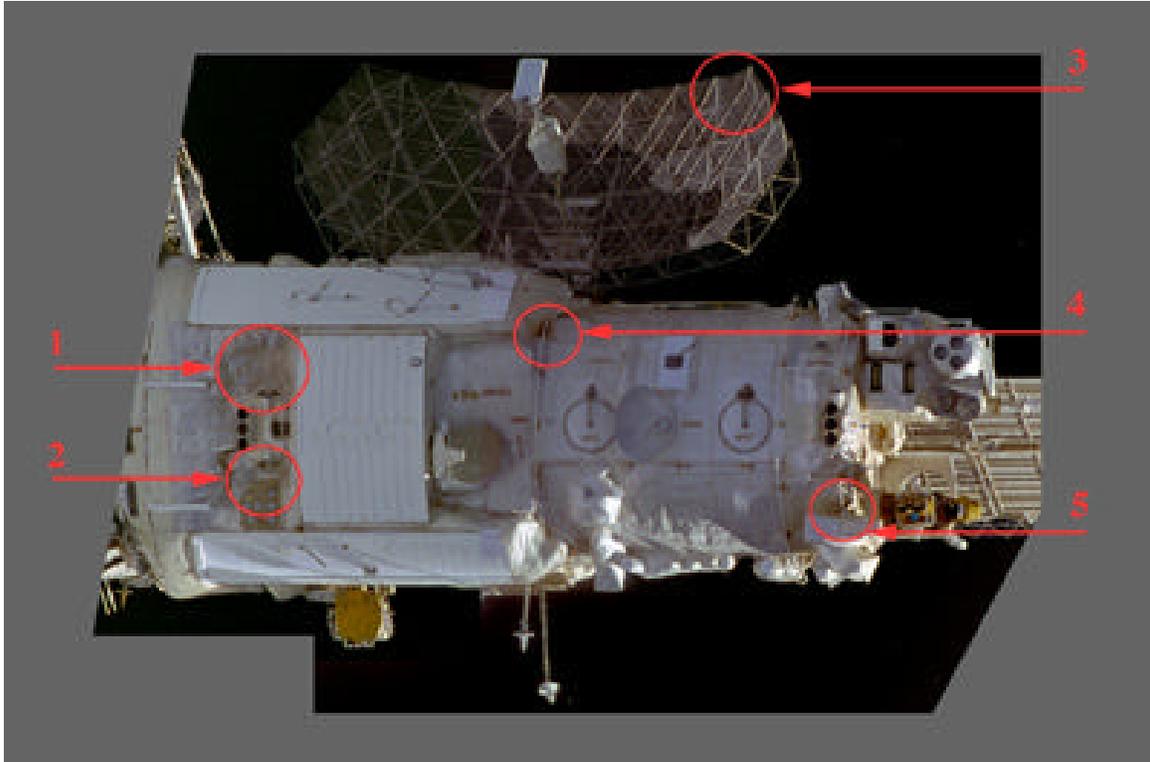
Figure 3.7 Priroda as seen from the -XB Direction

- Discoloration on the thermal blanket near the aft thruster engines. [1, 2]
- Three of the trusses of the SAR antenna have bends. [3]
- Dark discoloration on the thermal blanket near the EVA attach point [4] and beneath the EVA handrail [5].

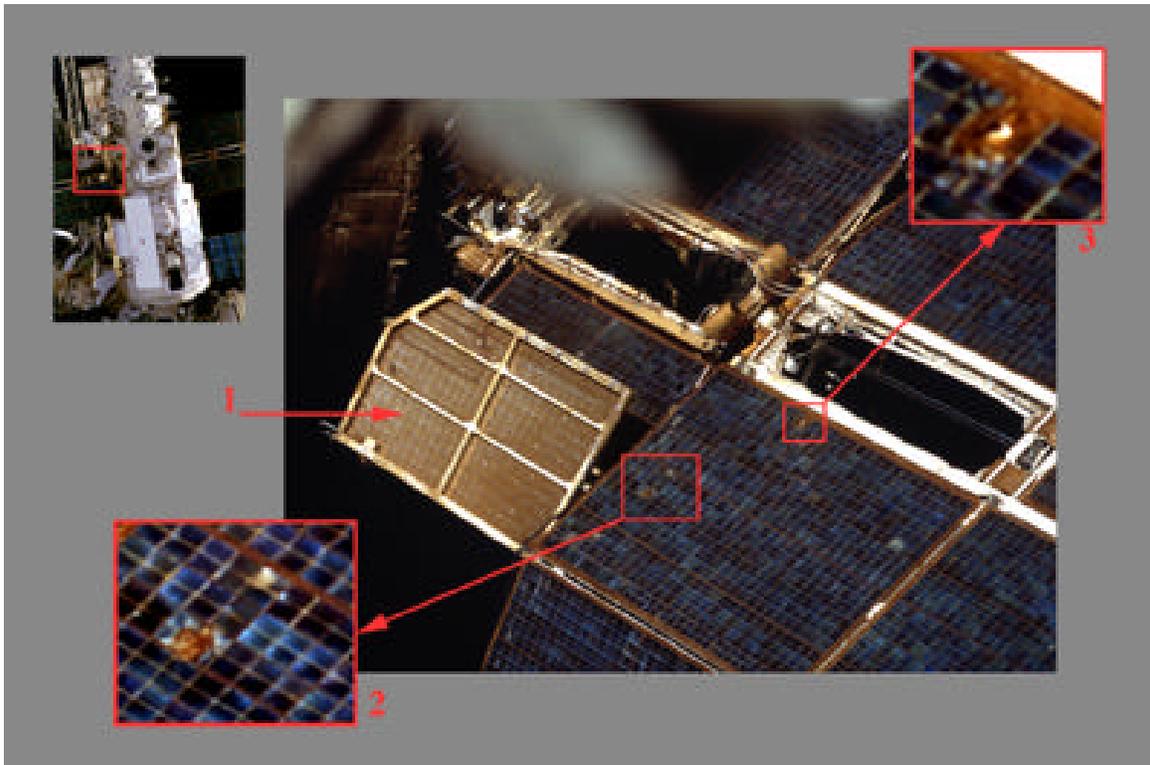
Figure 3.8a Kvant-2 - Solar Array: SP#2

This figure is a detailed view of the Kvant-2's SP#2 solar array. From this view and orientation of the array, two new features for this array are identified. The inset images show the splattered appearance of the cells. Six to eight adjacent cells appear to be affected for each of the two features. The inset on the right indicates the presence of a hole, which suggests penetration of some impact material.

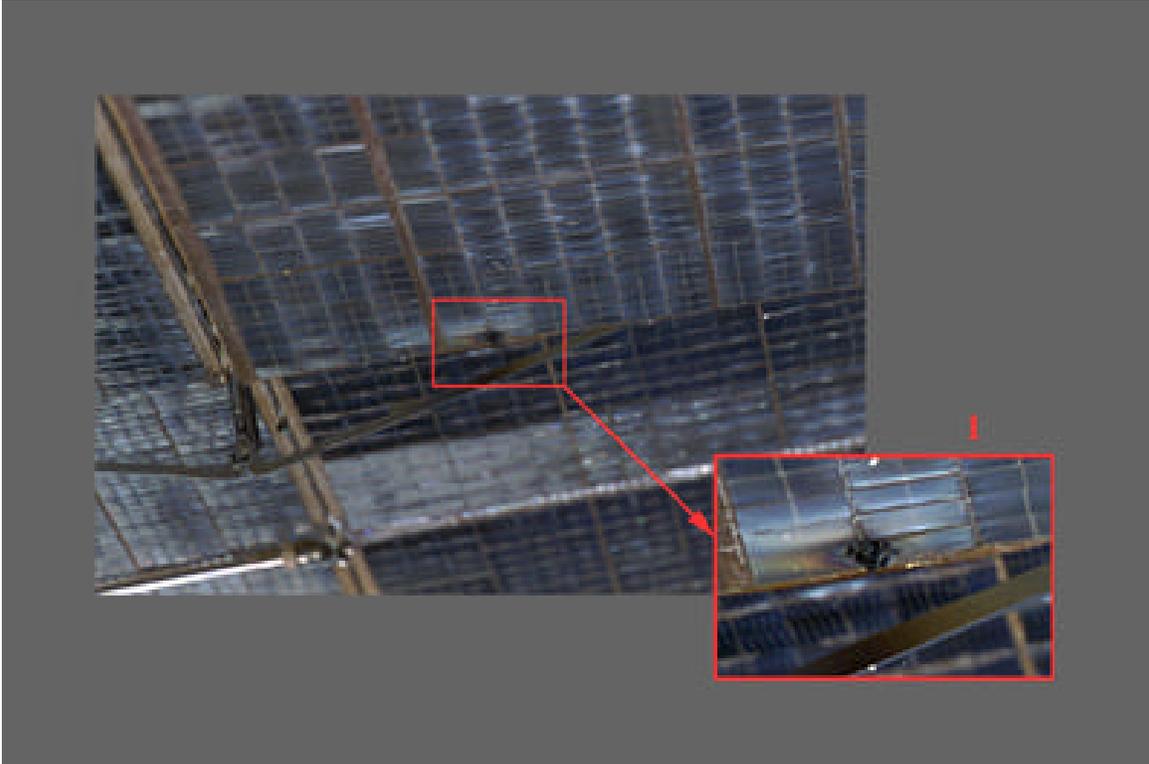
Figure 3.8b Base Block - Solar Array

This figure provides a detailed view of the underside of the solar array panel. The image insert provides an enhanced image showing apparent damage to the metallic support structure. The source cause of this damage is not known.

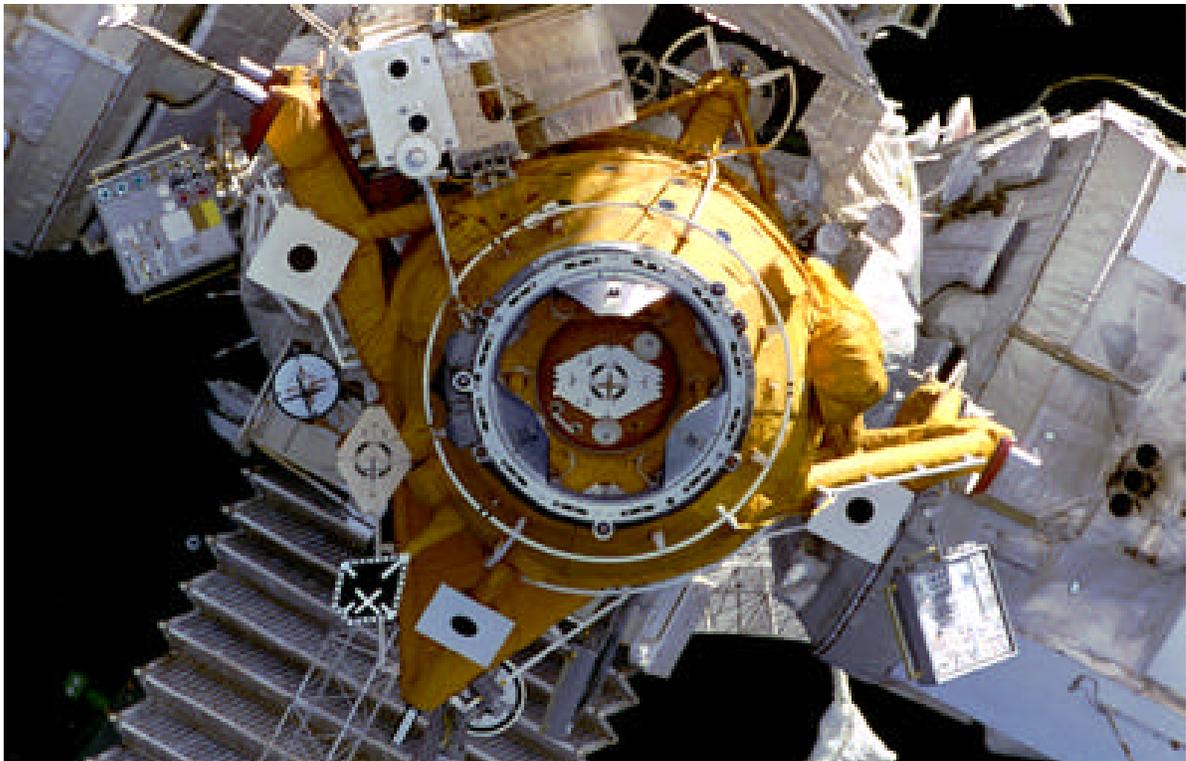
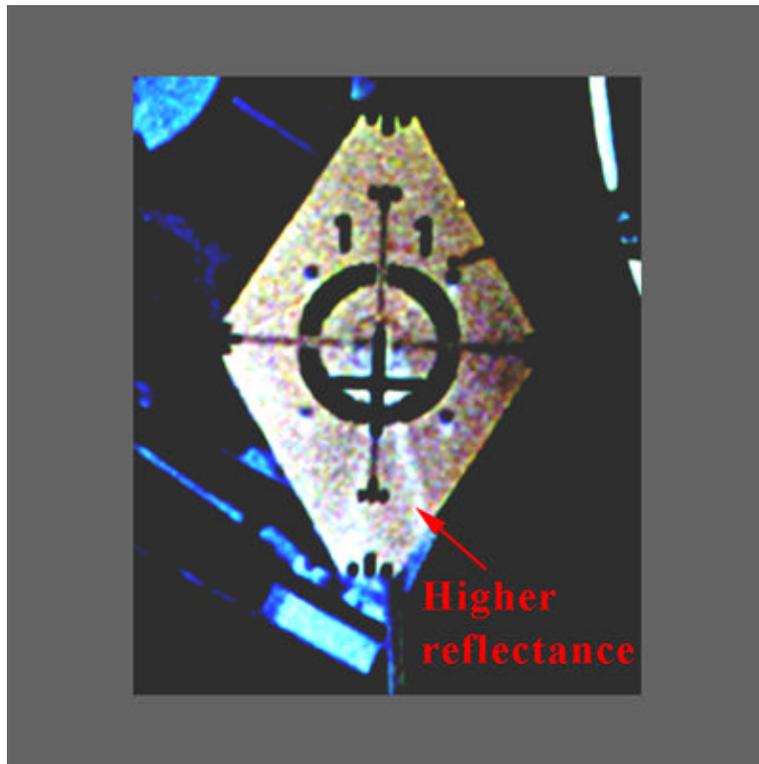
During STS-81 approach, photography of the docking mechanism was taken with the Nikon 35 mm camera and the 400 mm lens. An image, taken at a distance of approximately 215 feet, is shown as Figure 4.1. The image is a face-on view of the docking mechanism and shows the docking mechanism to be in good condition, with latches in proper position.

The only identifiable discoloration is on the non-axial docking target backplate as shown in Figure 4.1 and Figure 4.2. The discoloration, also observed on STS-79 imagery, is detectable since the stand-off target apparently shielded the backplate and, as a result, there is a narrow strip that is less discolored. A second strip of less discoloration also exists, indicating there may have been two sources of discoloration, or the same source from two separate orientations.

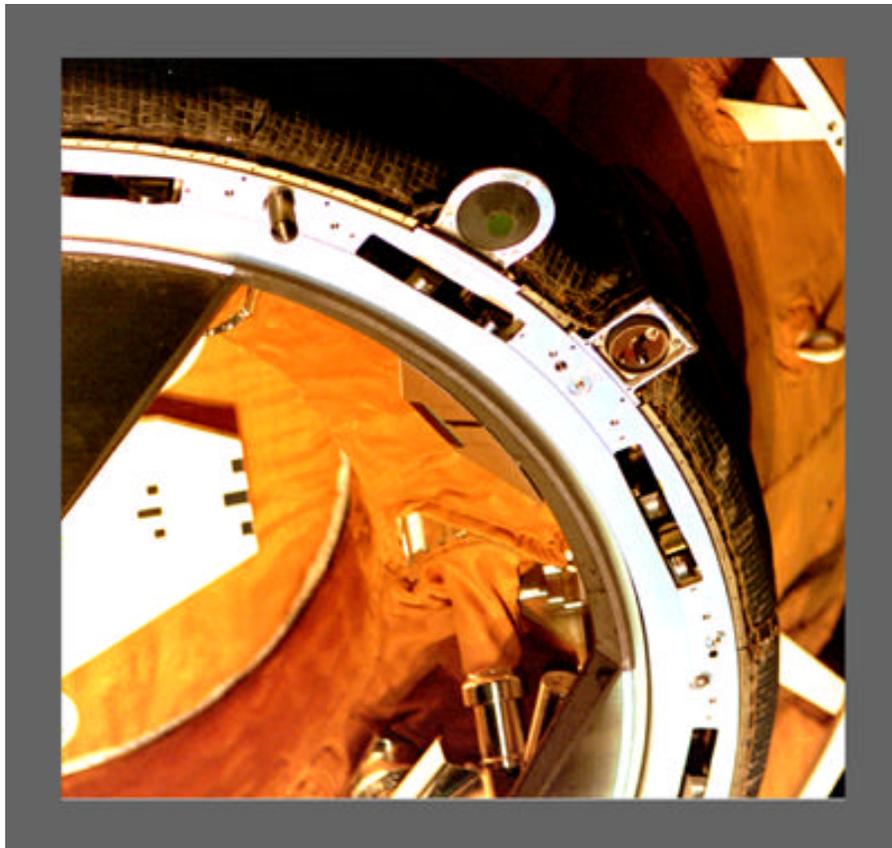
Figure 4.4 Image of Portion of Docking Mechanism during Backaway

Several close-up images were taken during backaway with the 35 mm camera from the Shuttle overhead windows. One of the highest resolution images of the docking mechanism is shown in Figure 4.4. Figure 4.4 is the portion covering the docking ring in the original image and has been enhanced in brightness and contrast from the digitized image. Figure 4.4 and similar images show the structural latches, capture latches, alignment guides, centerline target, laser retroreflectors, and electrical connectors in considerable detail. Each part of the docking mechanism appears to be in excellent condition for the subsequent Shuttle docking to Mir. The highest resolution images show possible traces of discoloration on the docking ring adjacent to some of the structural latches. There are also small, isolated traces of apparent discoloration in other locations. The traces of apparent discoloration observed on the docking ring do not extend to the electrical connectors.

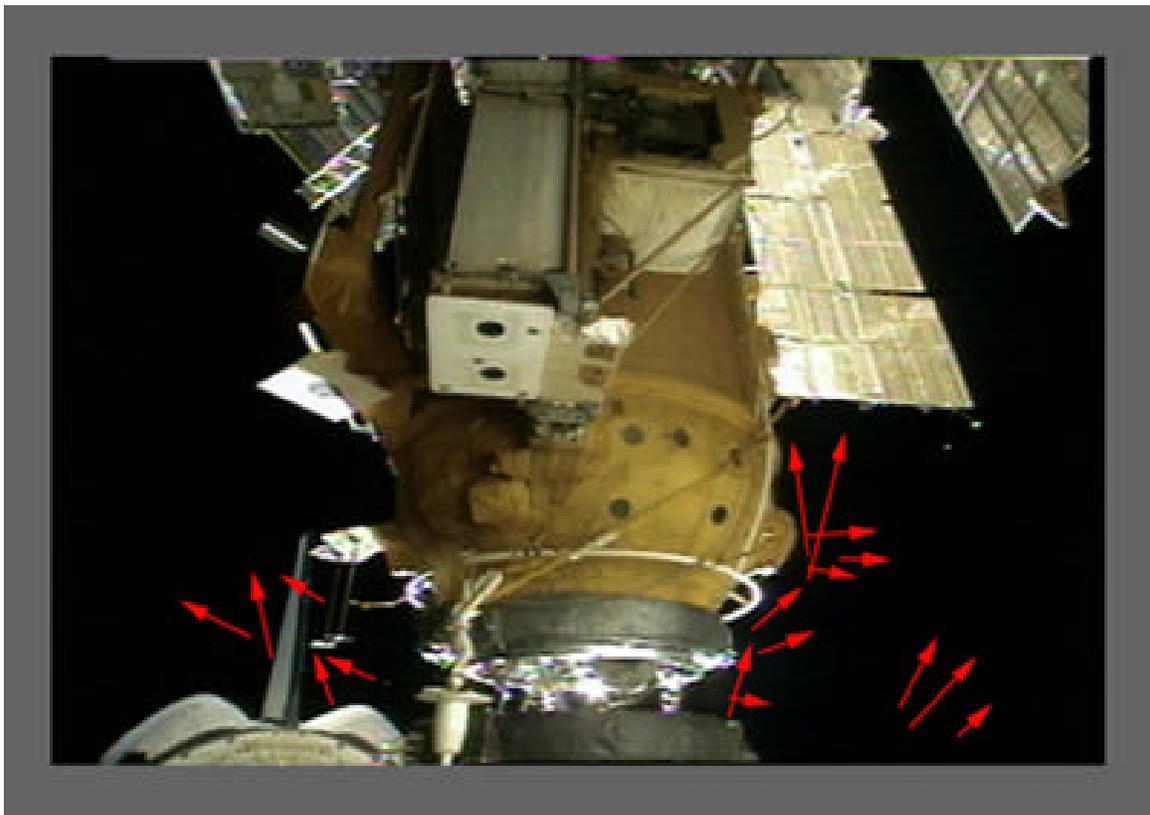
Figure 6.1 Trajectories of Small Debris Observed during Soft Dock

Directions of representative debris originating from the payload bay and from the DM/ODS interface area are shown in Figure 6.1. The debris was observed with PLB Camera D between GMT 015:03:55:14 and 03:56:43. Some of the debris appears to be tumbling, with a “flat” side, and hence is visible only on intermittent frames. Despite their apparent proximity to the Mir, none of the debris is seen impact the Station.
